Lorry Engine Repaired with Belzona

ID: 7576

Customer Location: *Transport company, Slovakia*
Application Date: *2014*

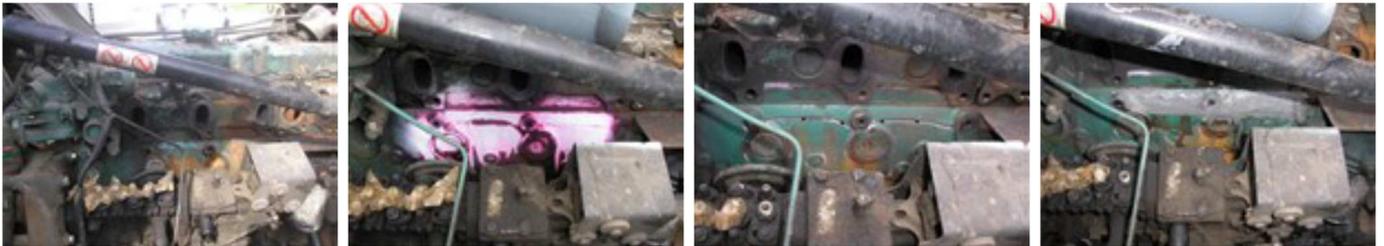
Cracked block due to freezing over winter months

1. Cracked engine
2. Crack detection to identify all cracks
3. Surface preparation
4. Belzona® 1111 repair incorporating Belzona® 9341 Reinforcement Tape

Welding of this damage would take a long time and potentially cause more damage so repairing with Belzona® 1111 was much better for customer.
