Belzona Seals Skylights Over Production Hall

Customer Location: *Machinery plant, Slovakia*

Application: *RPA-Roof Problem Areas*

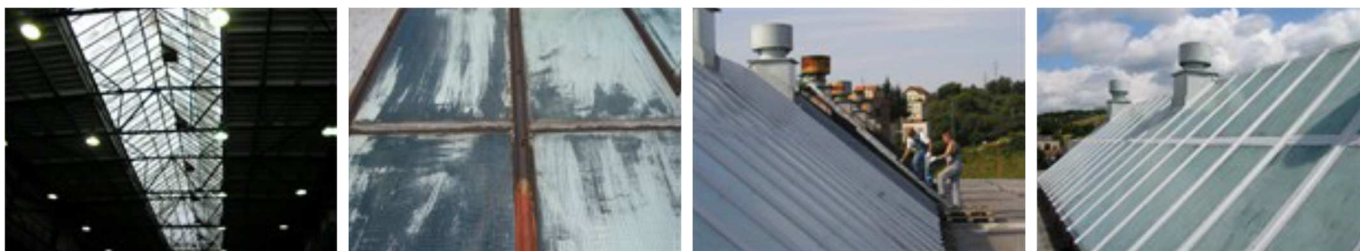
Photograph Descriptions

Corrosion of steel frame and rubber seal degradation on the skylights, caused by the effects of weather, was allowing rainwater to leak directly into the production hall creating safety issues and damage of interior machinery.

1. Skylights on the production hall
2. Corrosion of steel frame
3. Application in progress
4. The skylights in "as new" condition

Application was carried out in accordance with Instructions for use. A fully reinforced Belzona® 3111 system was applied to bridge over the glazing bars and seal onto the glass.

To replace the rubber seals would take a longtime and expose the interior to the full effects of the weather as well as interfering with production below. Repairs using the Belzona system was completed in 5 days without any disruption to the production process.
