# Belzona Rebuilds Shaft & Keyway on Jaw Crusher

ID: 1064

Industry: *General Industry* Customer Location: *Refractory manufacturer, Slovakia*  
Application: *MPT-Mechanical Power Transmission* Application Date: *2006*  
Substrate: *Steel*  
Products: *Belzona® 1111 (Super Metal)*

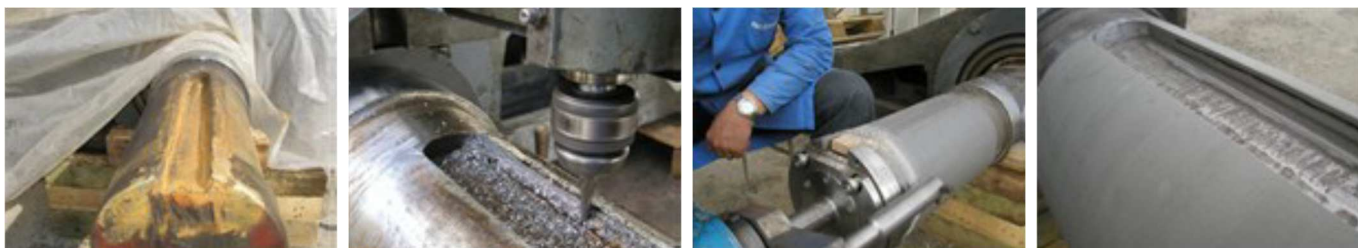
*Shaft and keyway worn and damaged*

1. Damaged shaft
2. Milling the keyway
3. Turning the Belzona® 1111 rebuilt shaft
4. Shaft ready to transport back to customer

Keyway was rebuilt by welding and milling operation. Belzona® 1111 was used for shaft repair, wooden former treated with release agent was used to form keyway. This repair saved customer a lot of time, because welding and drilling would have taken several weeks.
