Protection of Carbide Mixture Transfer Equipment with Belzona

ID: 1065

Industry: General Industry
Application: SHM-Solids Handling Machinery
Substrate: Steel
Products: Belzona® 1811 (Ceramic Carbide)

Customer Location: Calcium Carbide producer, Slovakia
Application Date: 2002, 2003, 2004

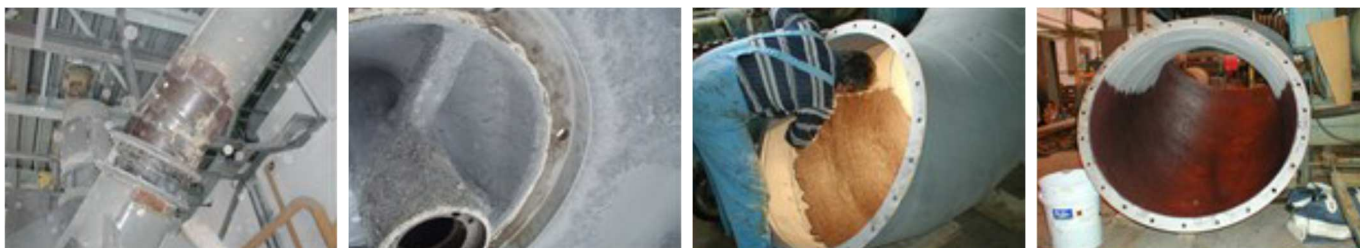
Photograph Descriptions

The highly abrasive carbide mixture wears tubes, pipe bends as well as the crusher itself.

1. Repair of the pipes was constantly required
2. The heavily damaged surface of the equipment
3. The application of Belzona® 1811 to pipe bend
4. The pipe bend ready for operation

Prior to the application it was required to change every 6 months the pipe sections as well as the parts of the crusher. Belzona application has prolonged the service life to 24 months, meaning that €24,000 was saved by customer over two years.
