Belzona Protects Pipeline and Valves from Cement Abrasion

ID: 2455

Industry: General Industry
Application: VPF-Valves, Pipes and Fittings
Substrate: Steel
Products: Belzona® 1811 (Ceramic Carbide)

Customer Location: Cement producer, Slovakia
Application Date: 2000

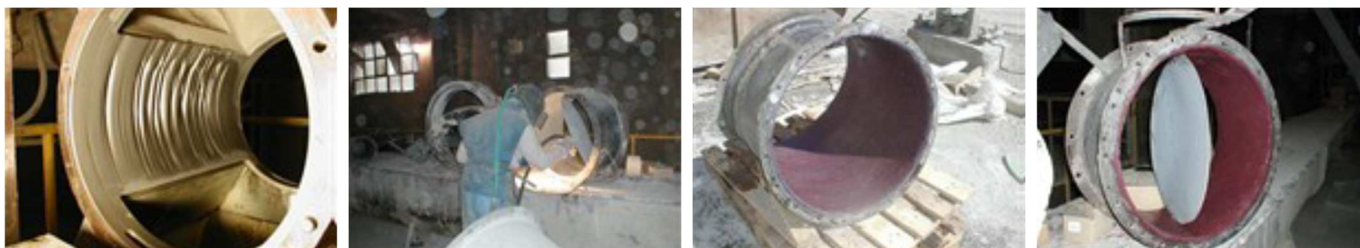
Photograph Descriptions

There was high abrasion caused by cement leading to local material loss of metal from valve body.

1. Badly eroded valve
2. Grit blasting the valves
3. Completed valve body
4. Re-assembled valve protected with Belzona® 1811

Application was carried out in accordance with Instructions for use.

The Belzona solution was initially accepted by customer because repair took only a few hours and the mill shut-down was very short. Since the first repairs in 2000 many more of these repairs have been completed.
