Large Storage Tank Protected with Belzona

ID: 7618

Crude oil storage tank.

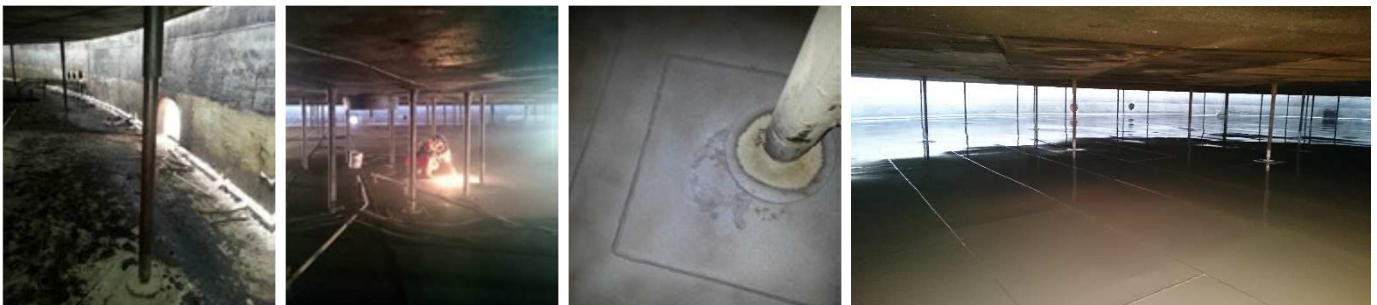
Photograph Descriptions

The tank had been in service for twenty years and was suffering extensive corrosion damage

1. Tank after 20 years
2. Blasting of the basin
3. Visible damages after blasting
4. Belzona® 5811 coating applied in 2 layers

Customer needed quick and quality repair. All protection was realized with Belzona® 5811. Deep corrosion was rebuilt with Belzona® 1111.
