Belzona Bonds Plates with Magnet Construction Support

ID: 8293

Industry: Chemical & Petrochemical
Application: TCC-Tanks and Chemical Containment Areas
Substrate: Steel
Products: Belzona® 1111 (Super Metal)

Customer Location: Crude oil production plant,
Slovakia
Application Date: 2020

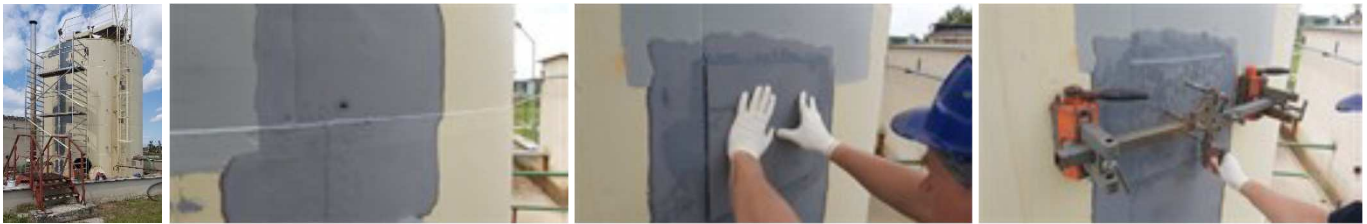
Photograph Descriptions

The tank was damaged by corrosion from aggressive residual water at crude oil production process. Because the customer needed very quickly repair he made decision to repair only damaged parts of the tank.

1. Tank was damaged by corrosion from aggressive residual water
2. Chemical corrosion leads to tank wall damage
3. Belzona® 1111 was applied directly onto the prepared surface
4. Magnet construction keeps plate on the right place with sufficient pressure

Chemical corrosion leads to tank wall damage.

Application was carried out in accordance with Instructions for use. The surfaces (tank and plates) were abrasive blasted to prepare the area and Belzona® 1111 was applied directly onto the prepared surface with a spatula.

This customer has perfect experiences with Belzona repairs and protection. Our suggest of this reparation offered to save him a lot of time without using some expensive tools. This was not our first time, when we have utilized this magnet construction to keep plates on the right place with sufficient pressure.
