# Belzona Distributor's Oven Helps for Quick Return to Service

Industry: *Chemical & Petrochemical*  
Application: *TCC-Tanks and Chemical Containment Areas*  
Substrate: *Steel*  
Products: *Belzona® 1391T*

Customer Location: *Bratislava, Slovakia*  
Application Date: *2019*

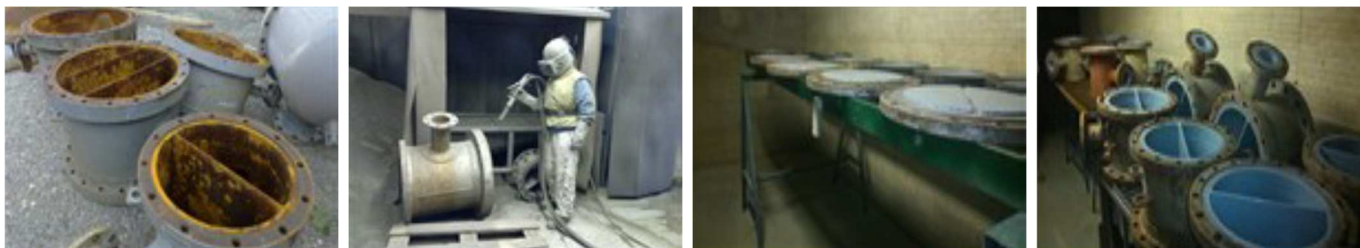
*Erosion and Corrosion to the exchanger parts required repairing. Belzona 1391T's time until full service was 28 days in 20°C so post curing was required.*

1. Customer needed to protect his parts of exchangers
2. Blasting and cleaning
3. Garage oven with remote temperature control
4. Coating exchanger parts to post cure

After blasting and cleaning, the parts of exchangers were coated with Belzona® 1391T. Application was carried out in accordance with Instructions for use. The distributor had prepared an oven in a concrete garage with glass cladding insulation, with heating and remote temperature control. The coated equipment was placed in the oven. The temperature was raised so that the coating was heated to a minimum 50°C for 1 hour.
