# Belzona Provides a Sliding Surface Repair on Sealing Rings

Industry: *Steel & Metal Processing*  
Application: *CEP-Centrifugal Pumps*  
Substrate: *Steel*  
Products: *Belzona® 1311 (Ceramic R-Metal)*

Customer Location: *Metallurgic plant, Slovakia*  
Application Date: *2016*

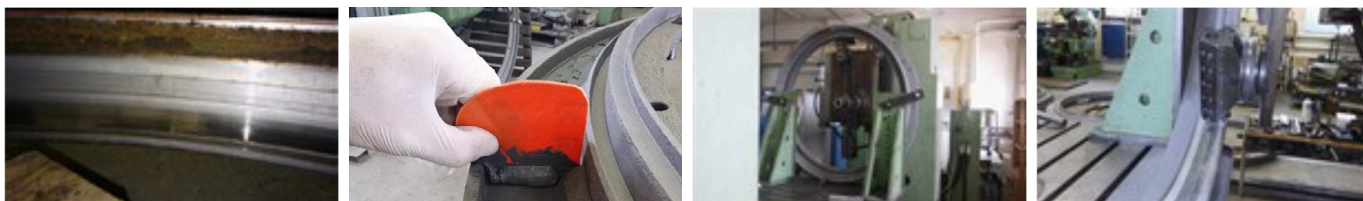
## Photograph Descriptions

*Erosion, corrosion*

1. Damaged surface
2. Belzona® 1311 application
3. Machining of Belzona® 1311 for right diameter
4. Machining of Belzona® 1311 for right diameter

Sliding surfaces of sealing rings were worn down from rubber sealing.

Application was carried out in accordance with Instructions for use.

Rings are too thin for welding and replacing is very expensive.
